**Draft Report
Project No. 60251**

**Volume 1 of 5
Remedial Investigation Report
ACS NPL Site
Griffith, Indiana**

**REMEDIAL INVESTIGATION REPORT
AMERICAN CHEMICAL SERVICES NPL SITE
GRIFFITH, INDIANA**

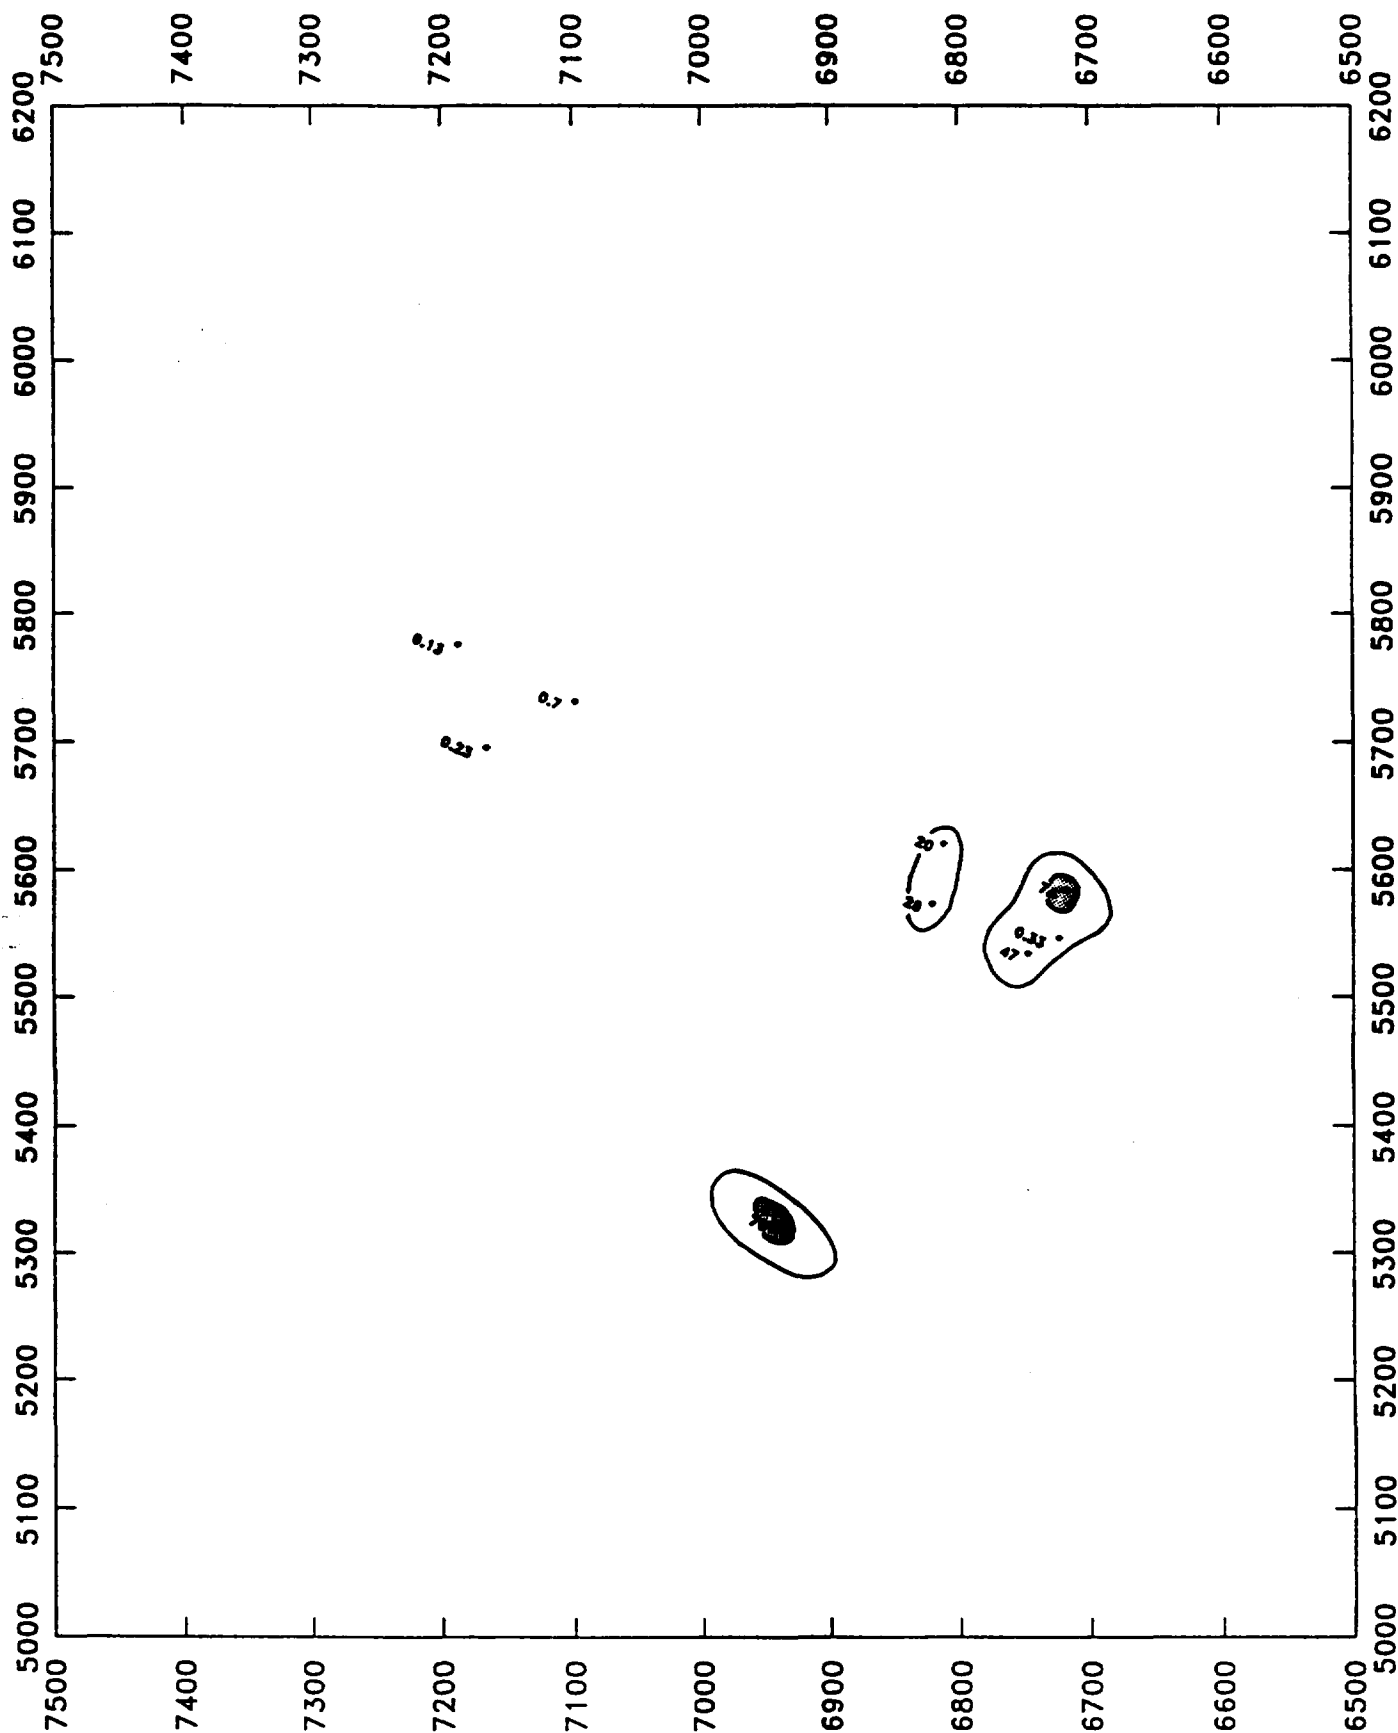
Figure 5-7c Approximate Extent of Total PCB Containing Wastes (> 1 ppm, shaded > 50 ppm), On-Site Areas (6-8 feet below surface)

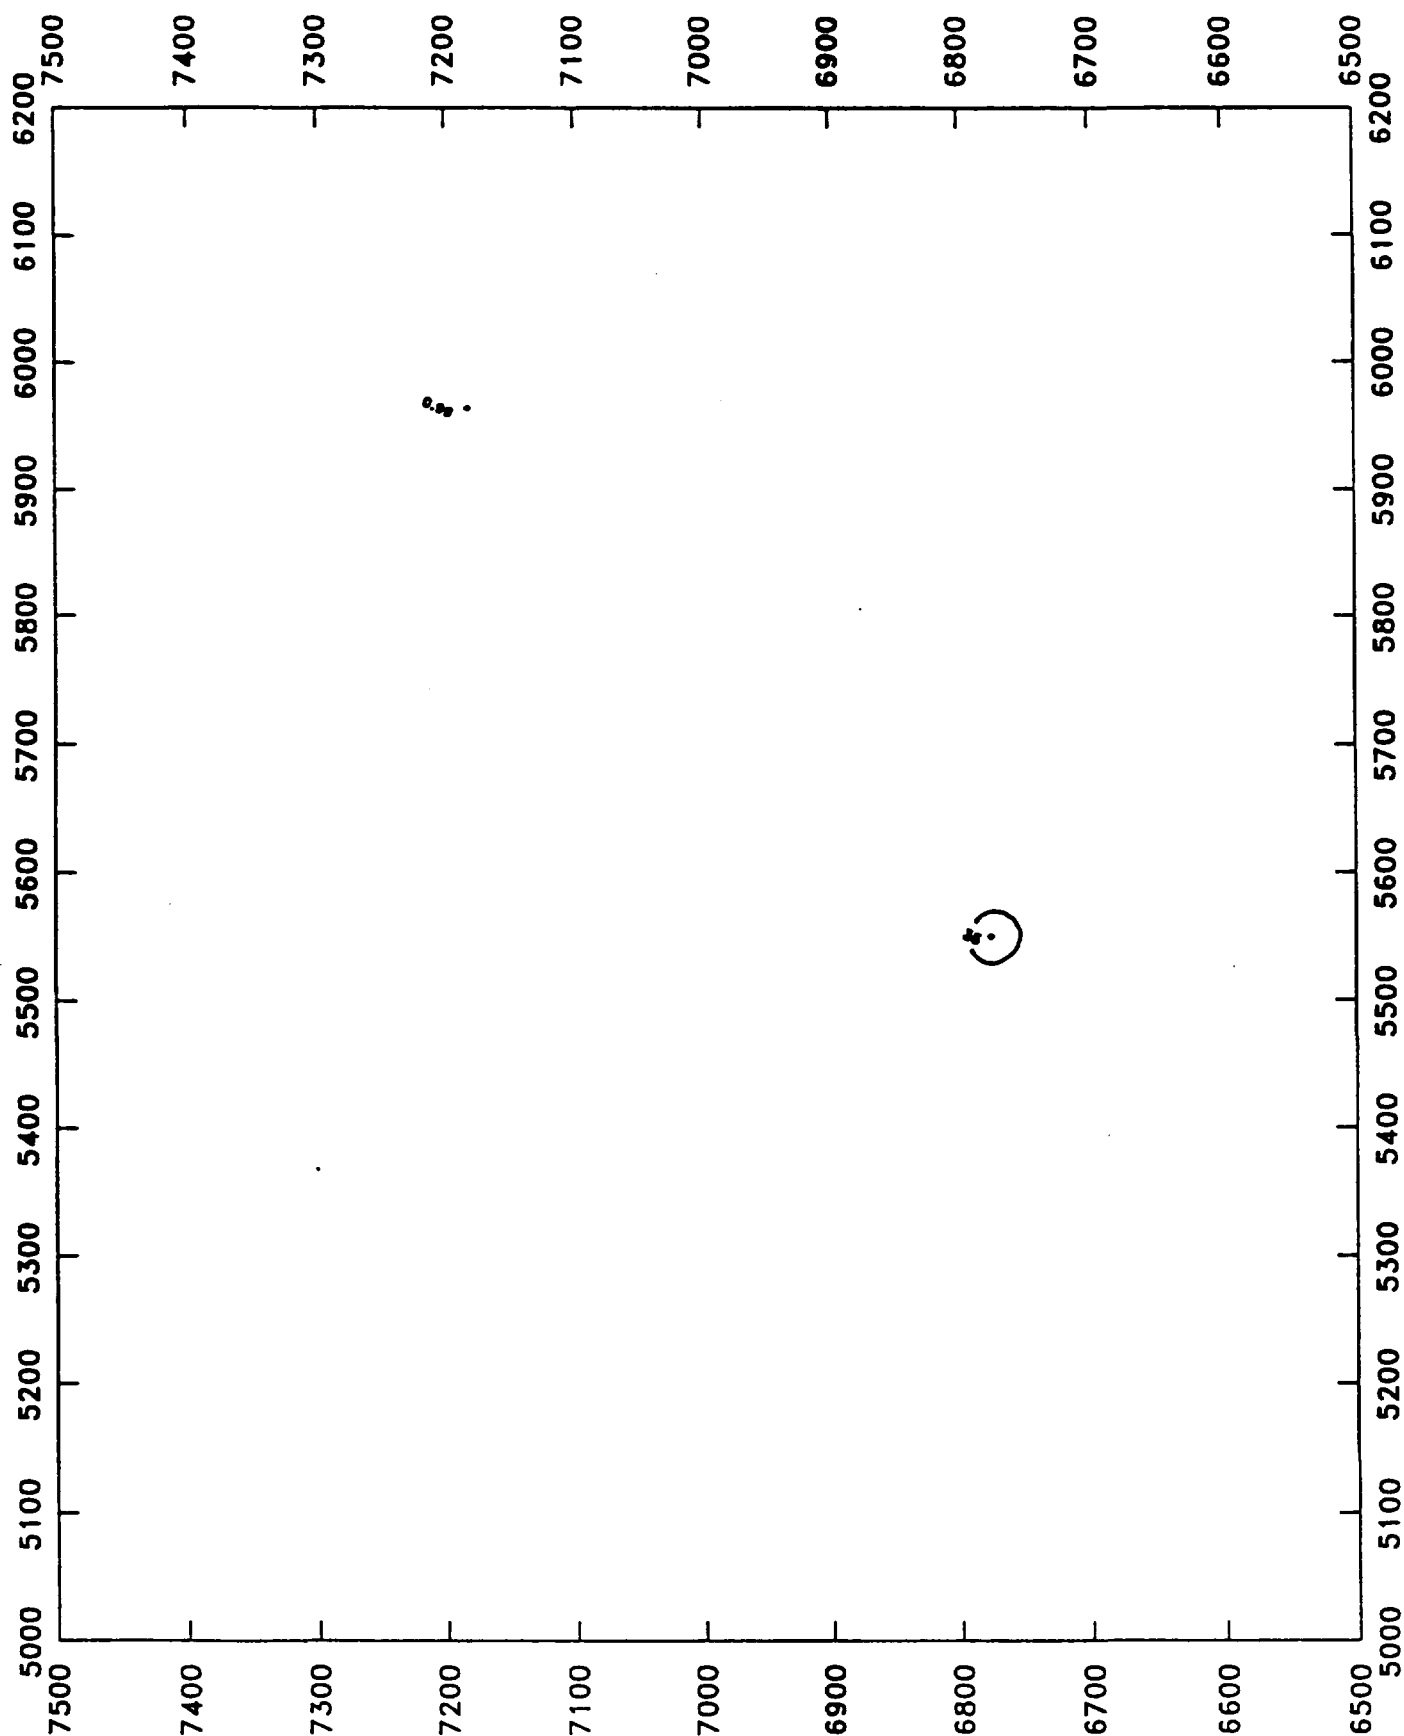
Figure 5-7d Approximate Extent of Total PCB Containing Wastes (> 1 ppm, shaded >50 ppm), On-Site Areas (8-12 feet below surface)

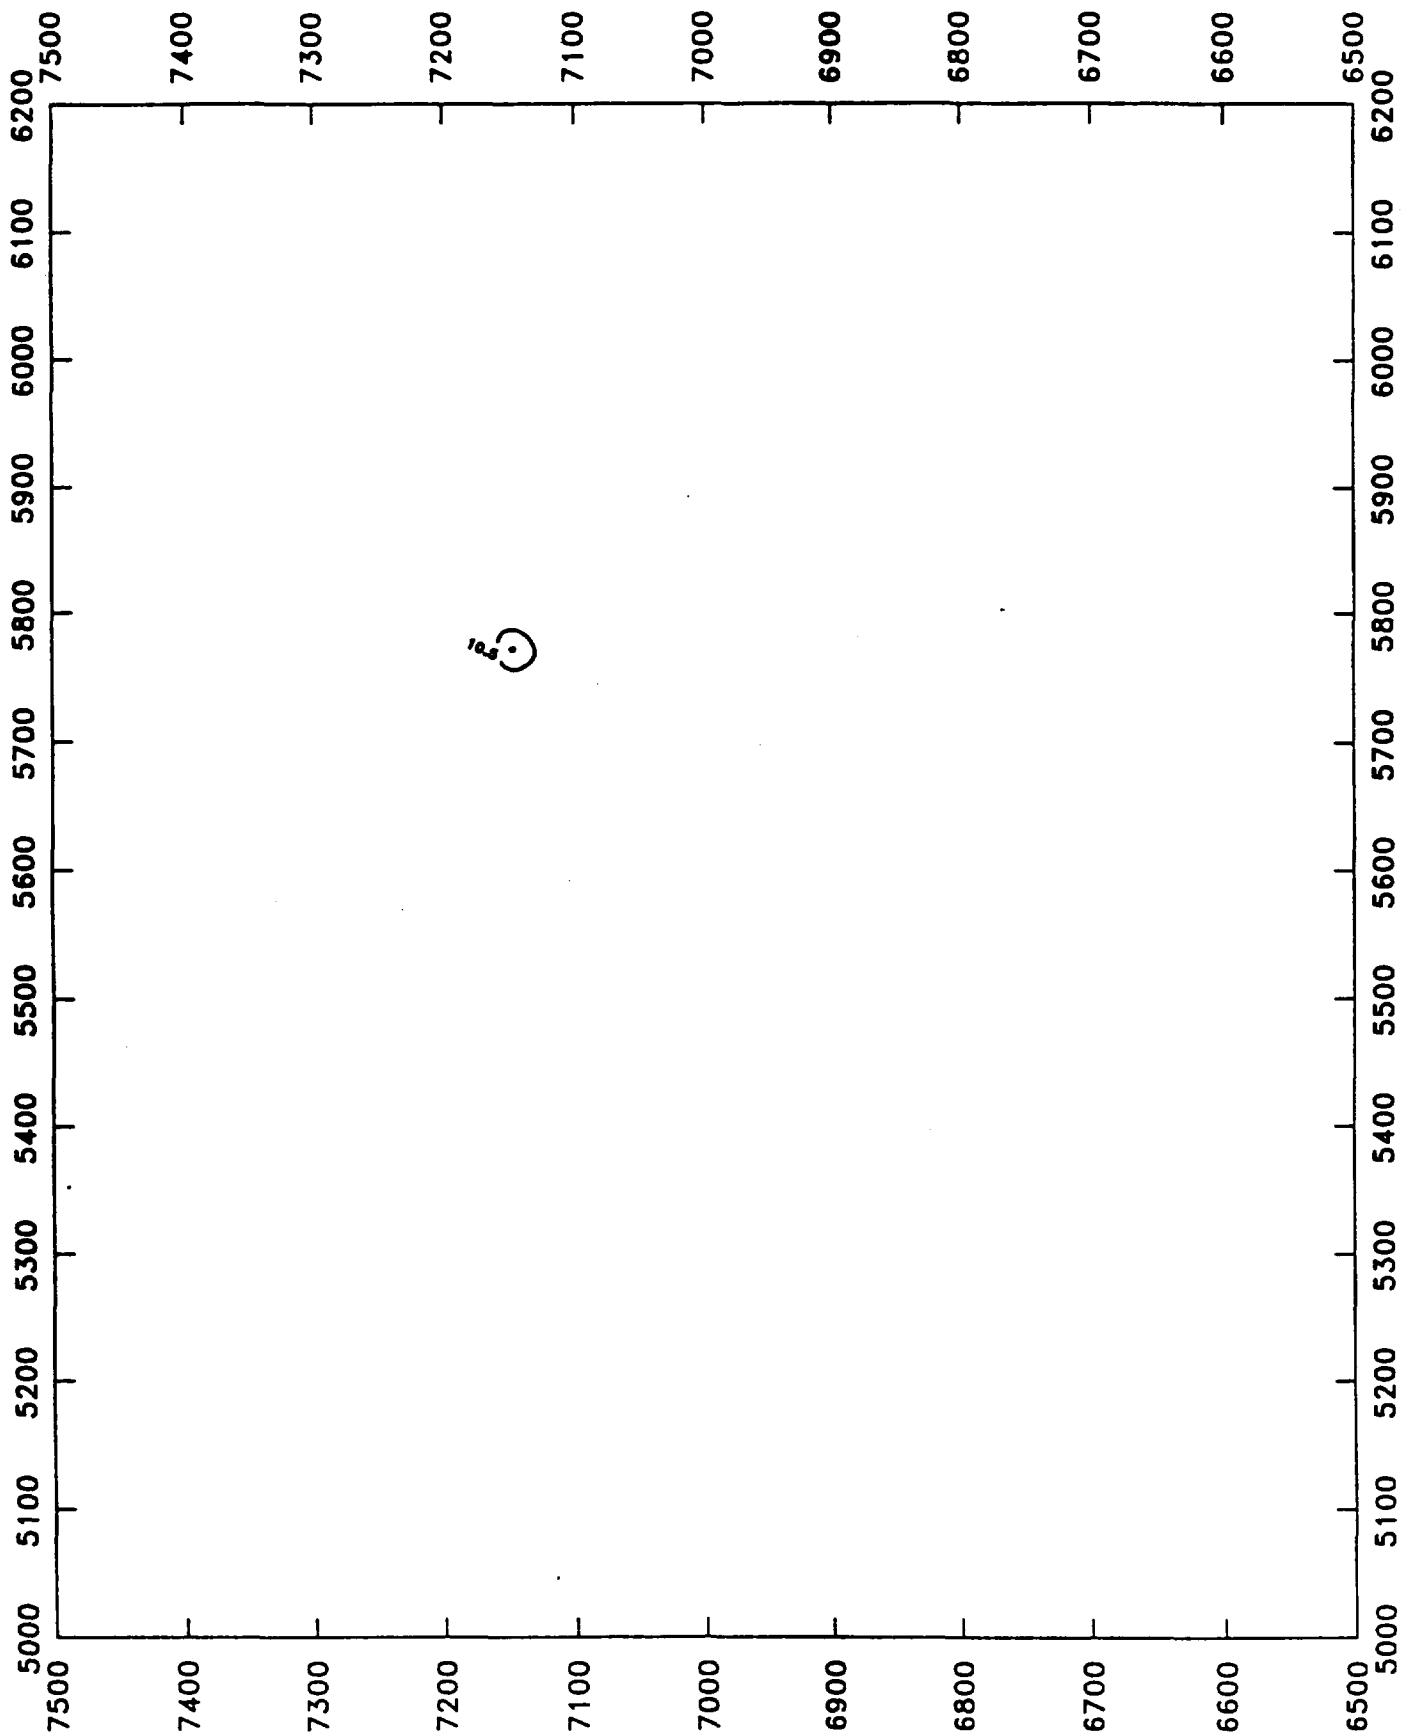
Figure 5-7e Approximate Extent of Total PCB Containing Wastes (> 1 ppm, shaded > 50 ppm), On-Site Areas (12-17 feet below surface)

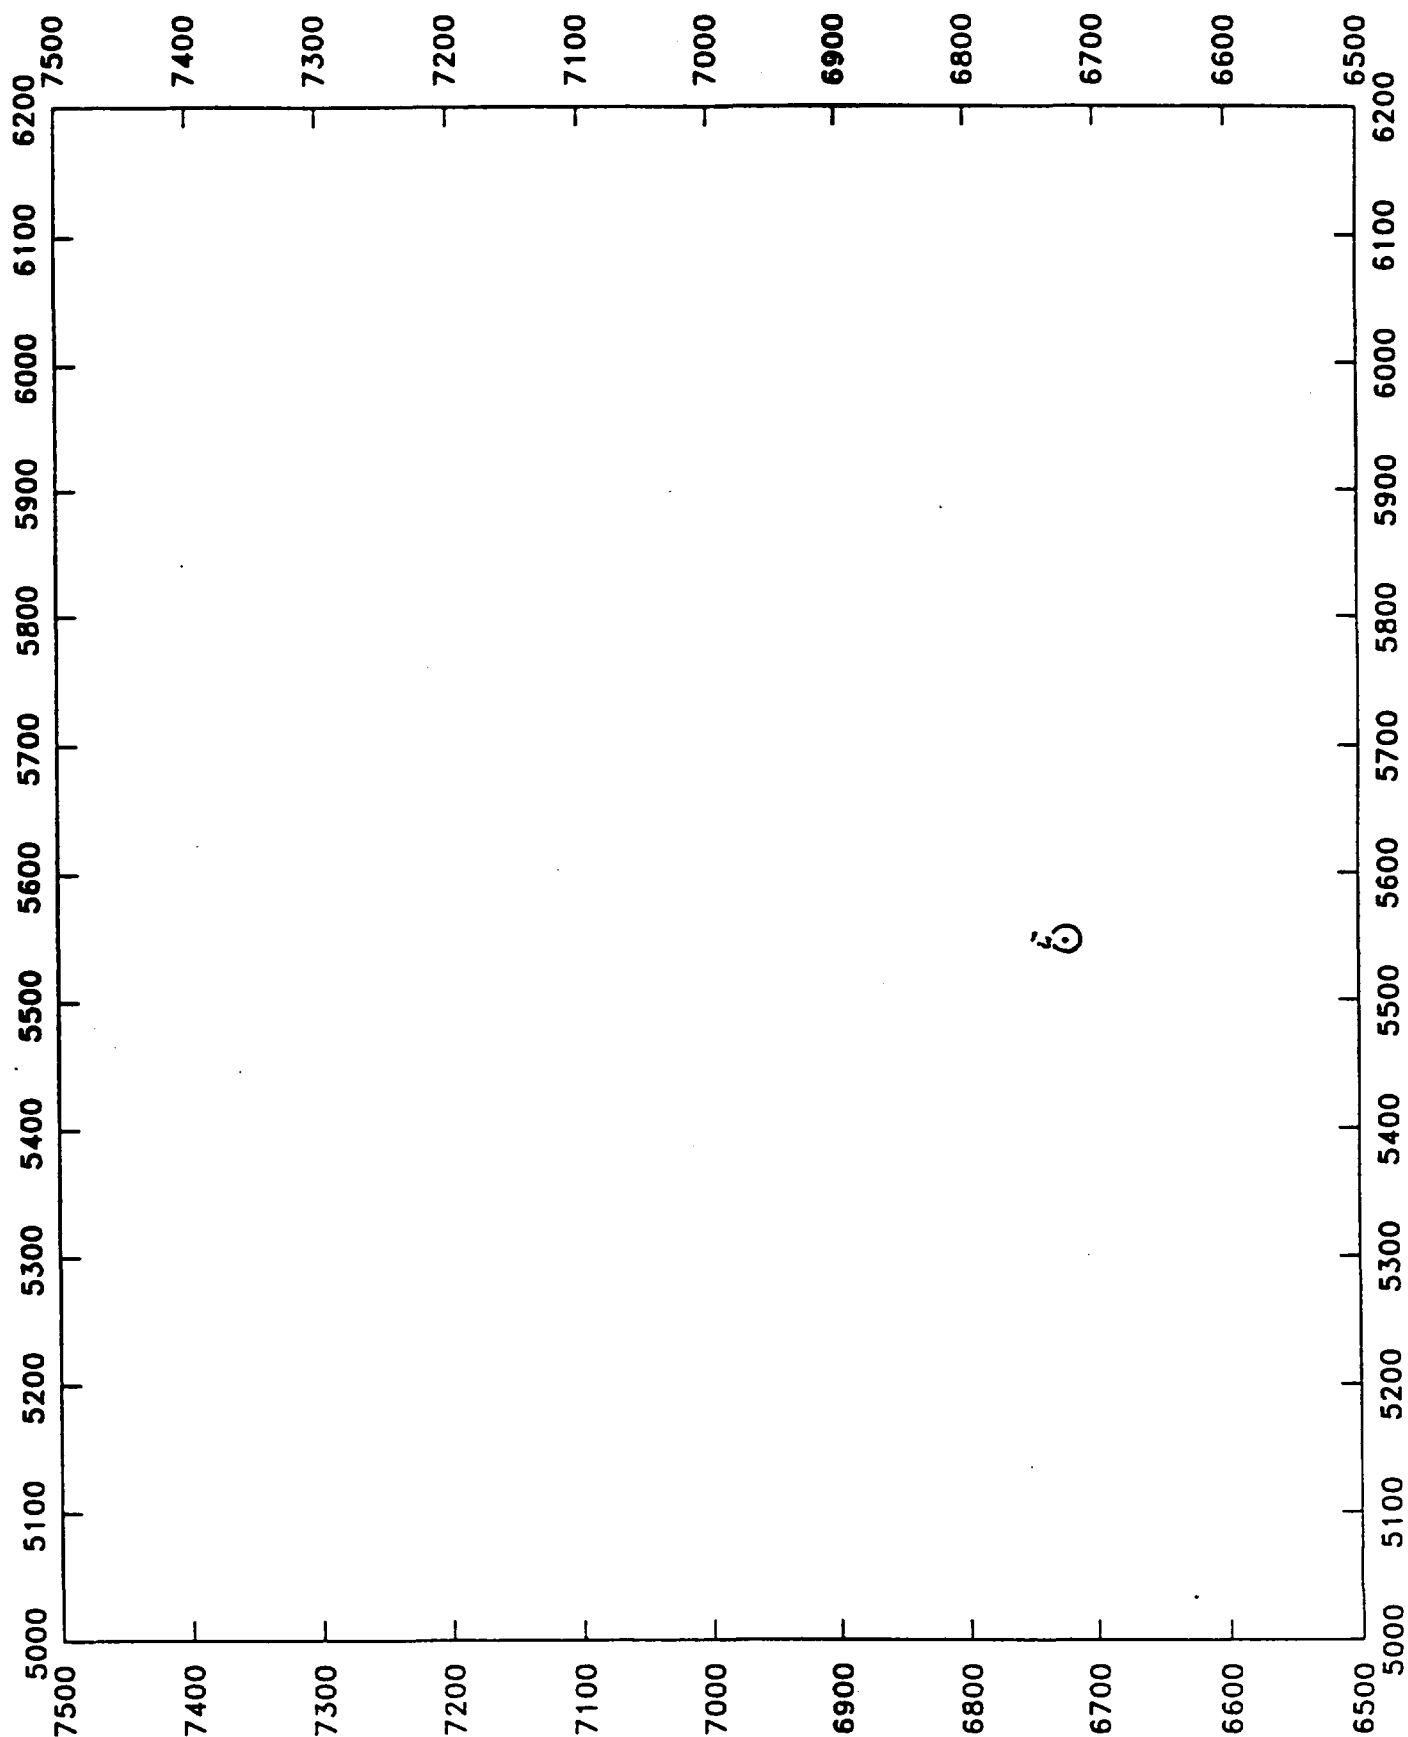
Figure 5-7f Approximate Extent of Total PCB Containing Wastes (> 1 ppm, shaded >50 ppm), On-Site Areas (17-20 feet below surface)

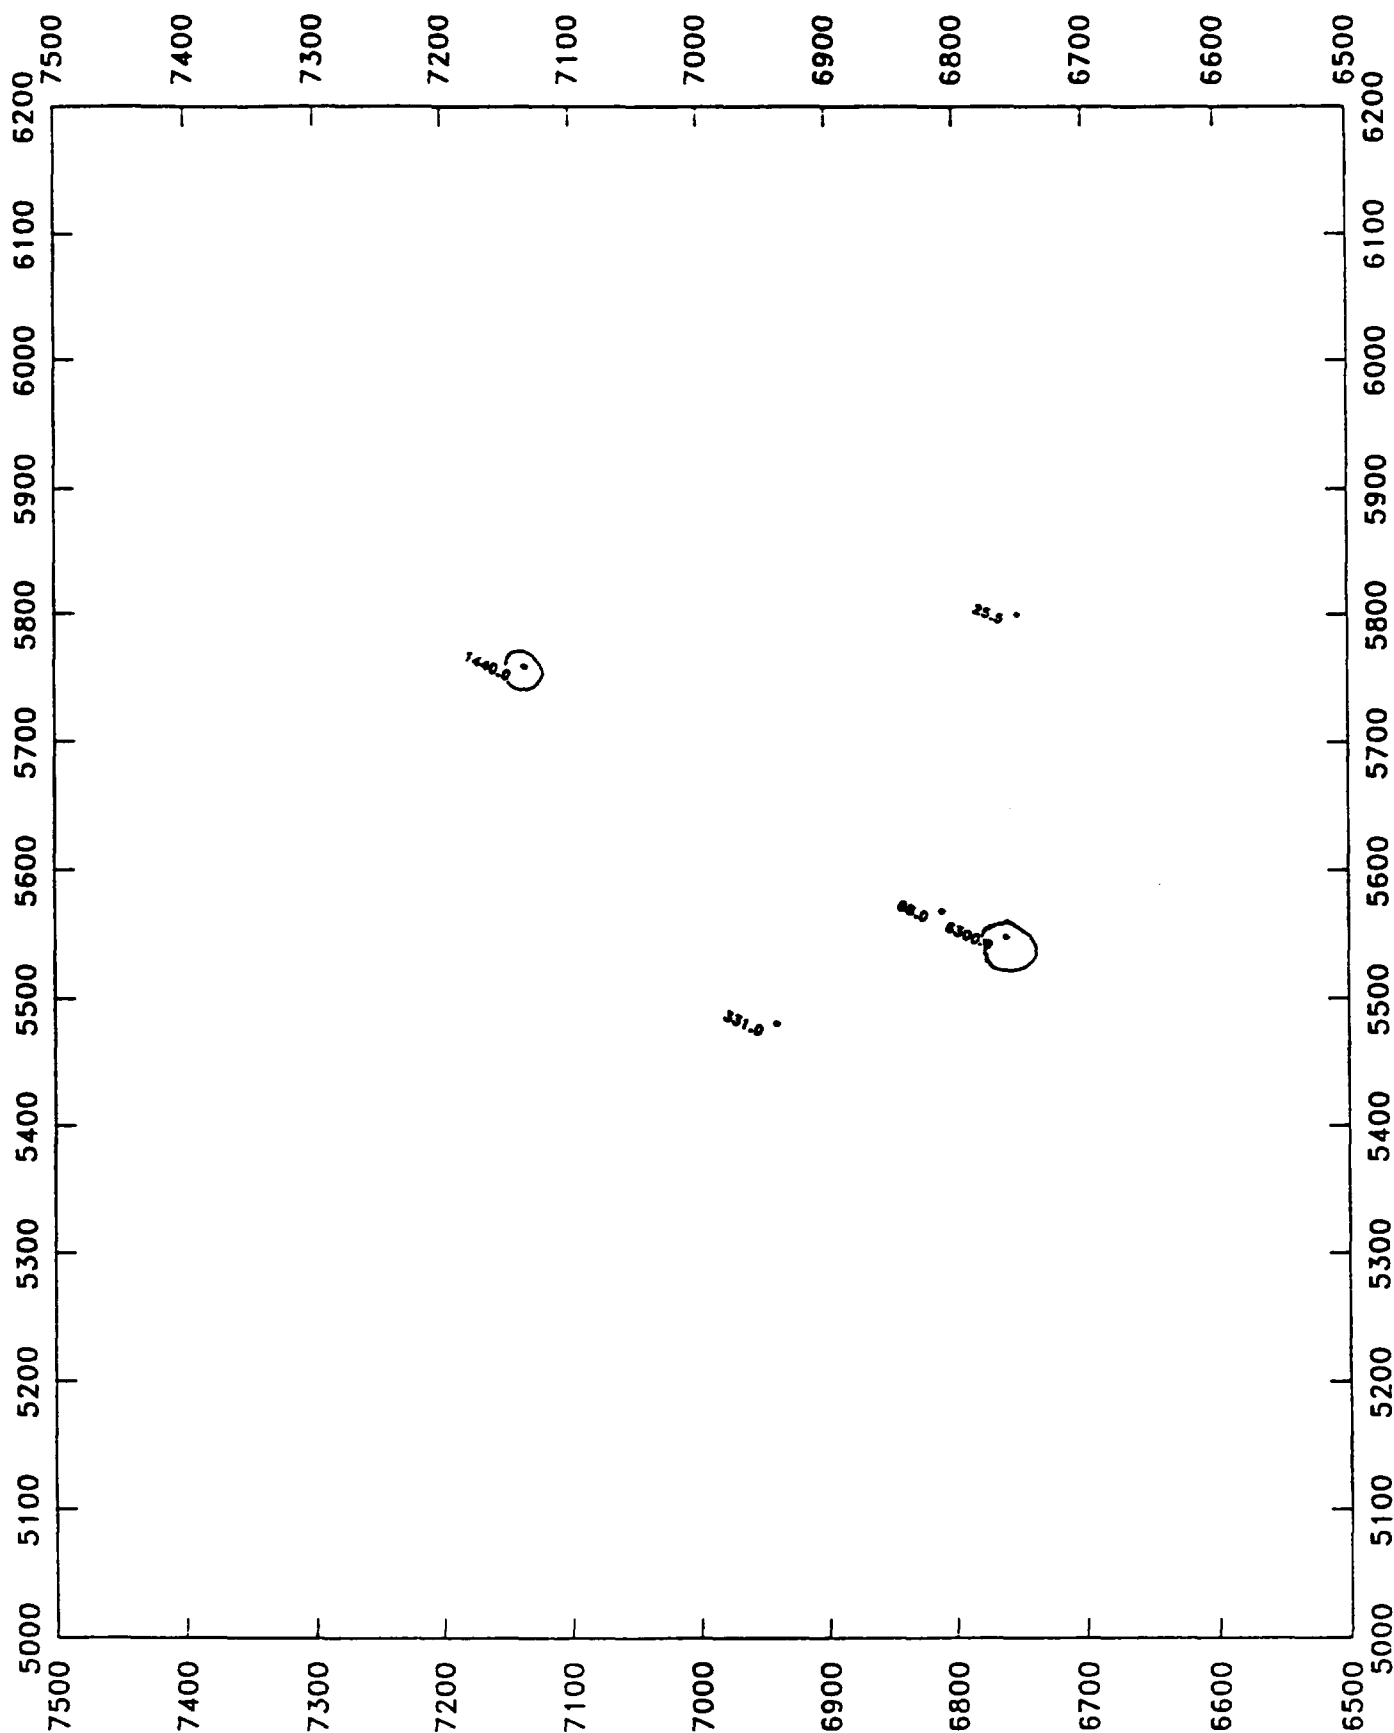
Figure 5-8a Approximate Extent of Lead Containing Wastes (> 500 ppm), On-Site Areas (1-4 feet below surface). Posted Values are in ppm (mg/kg).

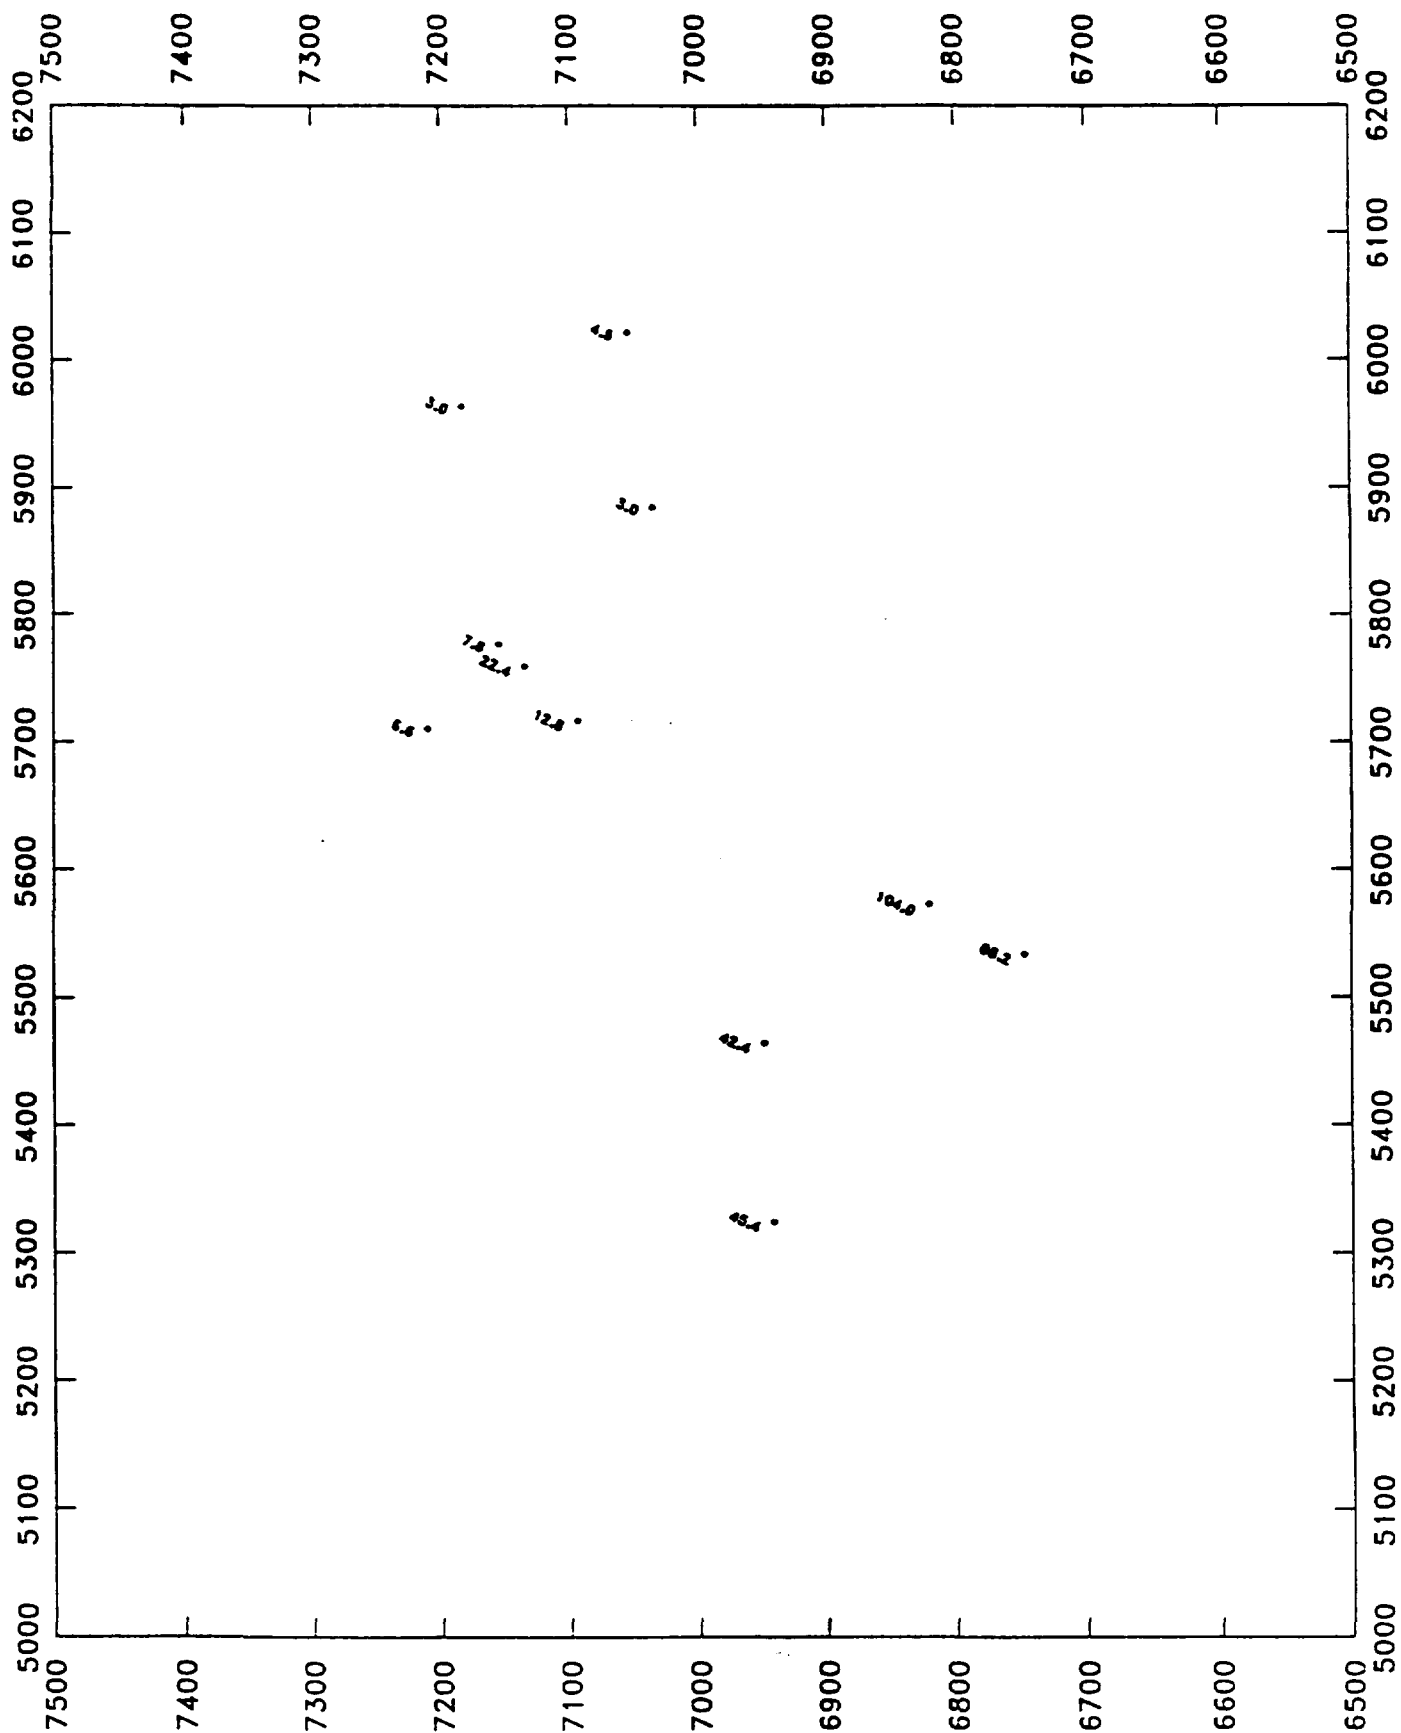
Figure 5-8b Approximate Extent of Lead Containing Wastes (> 500 ppm), On-Site Areas (4-7 feet below surface). Posted Values are in ppm (mg/kg).

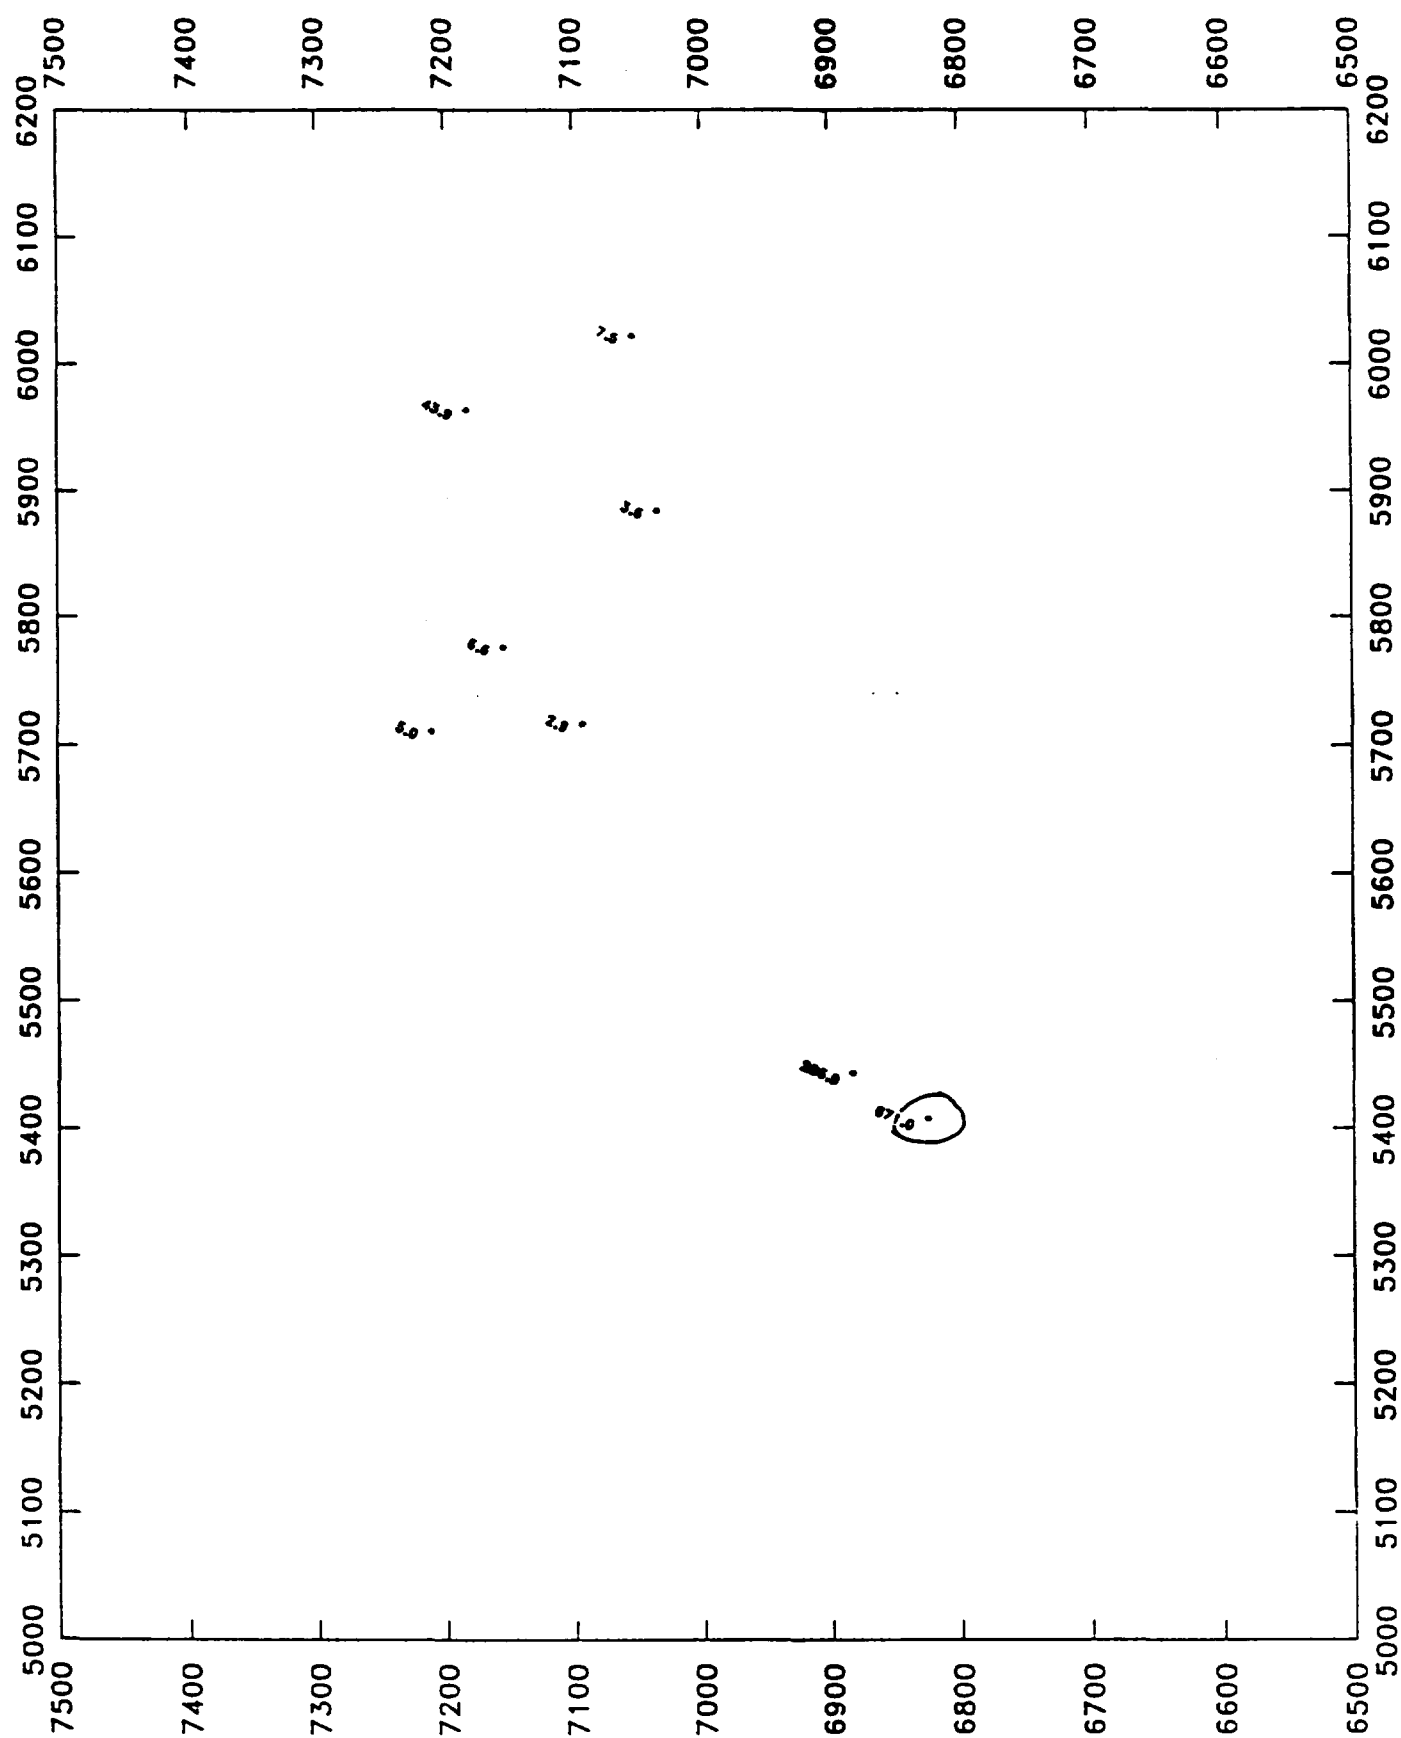
Figure 5-8c Approximate Extent of Lead Containing Wastes (> 500 ppm), On-Site Areas (7-10 feet below surface). Posted Values are in ppm (mg/kg).

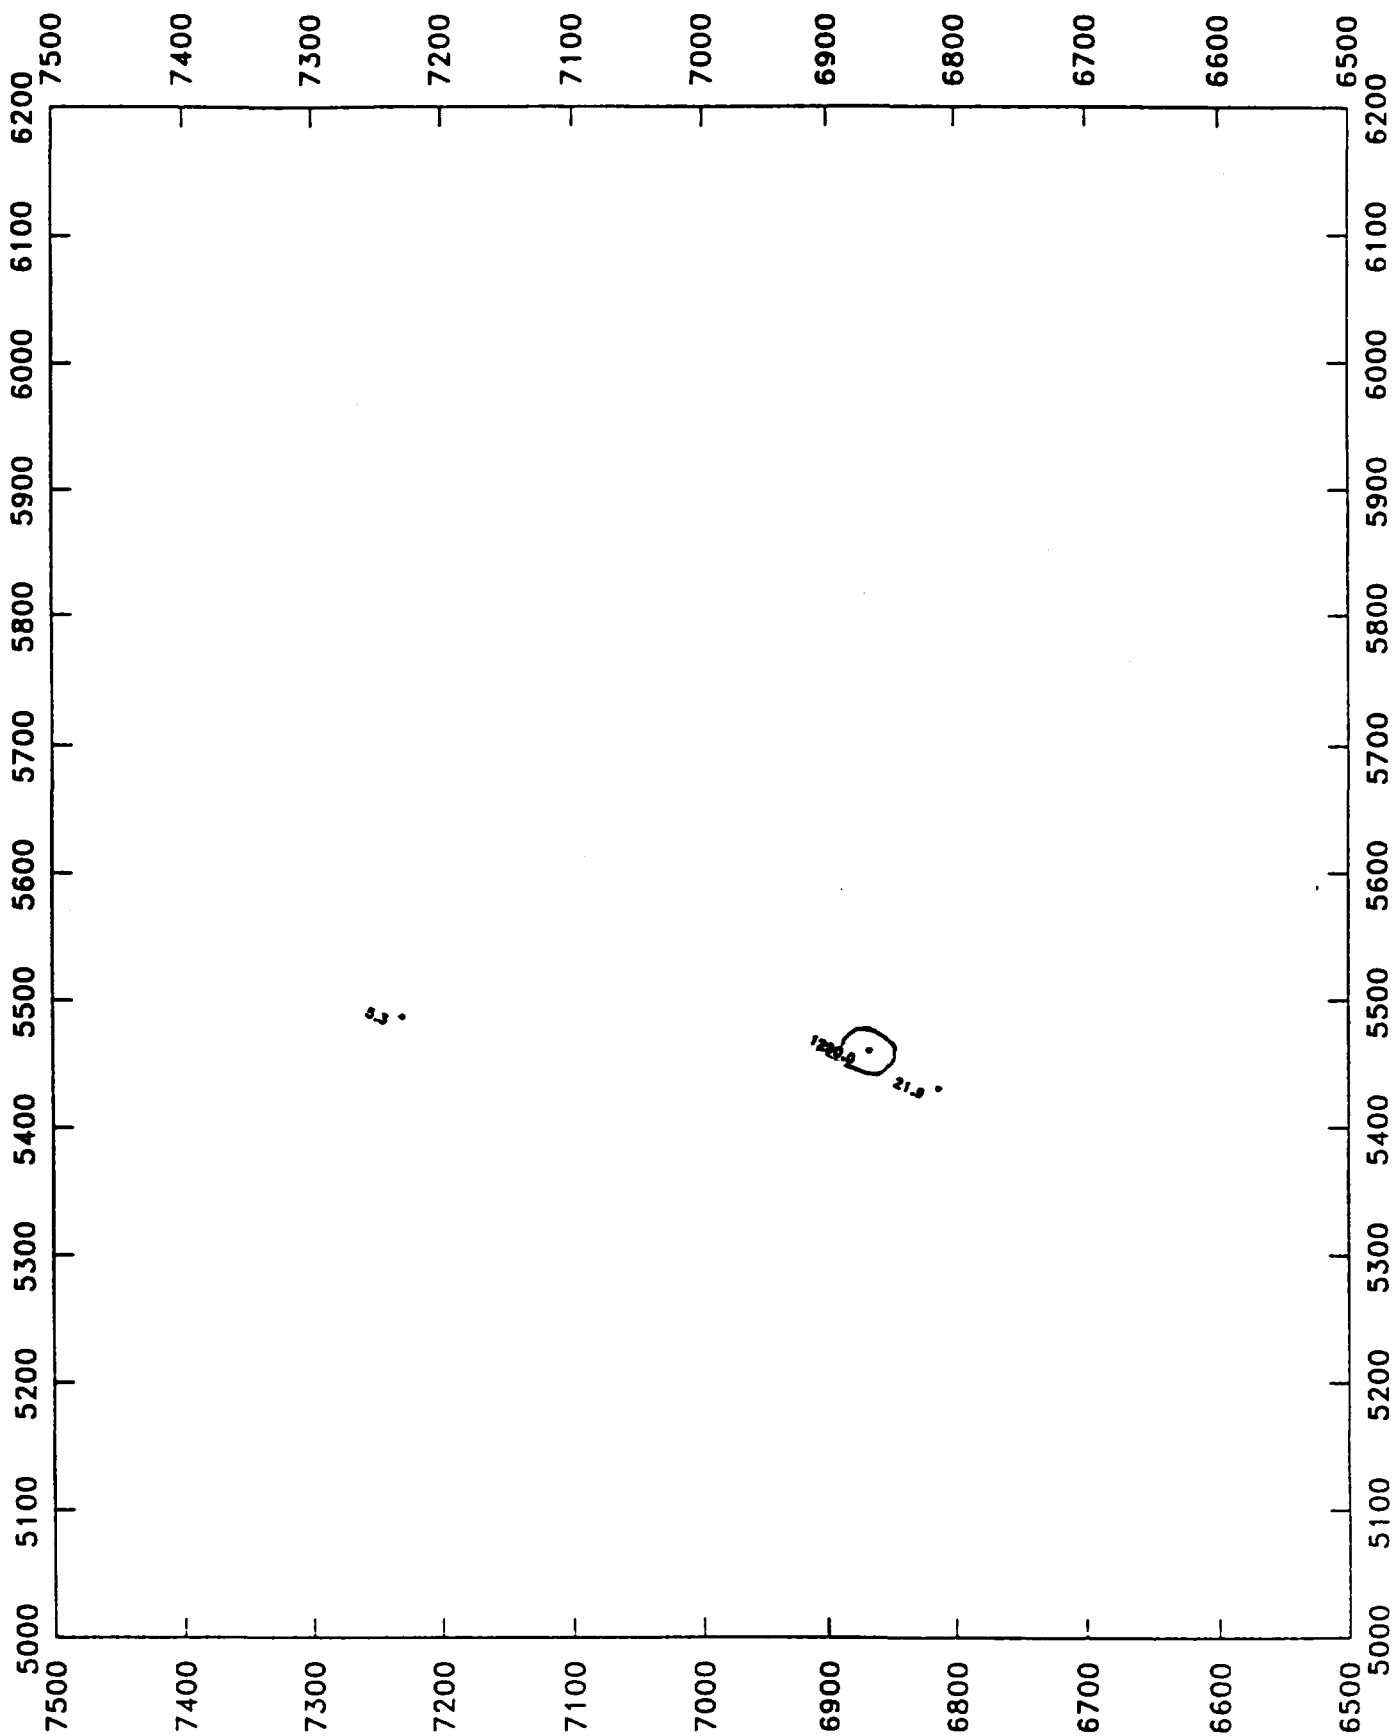
Figure 5-8d Approximate Extent of Lead Containing Wastes (> 500 ppm), On-Site Areas (10-15 feet below surface). Posted Values are in ppm (mg/kg).

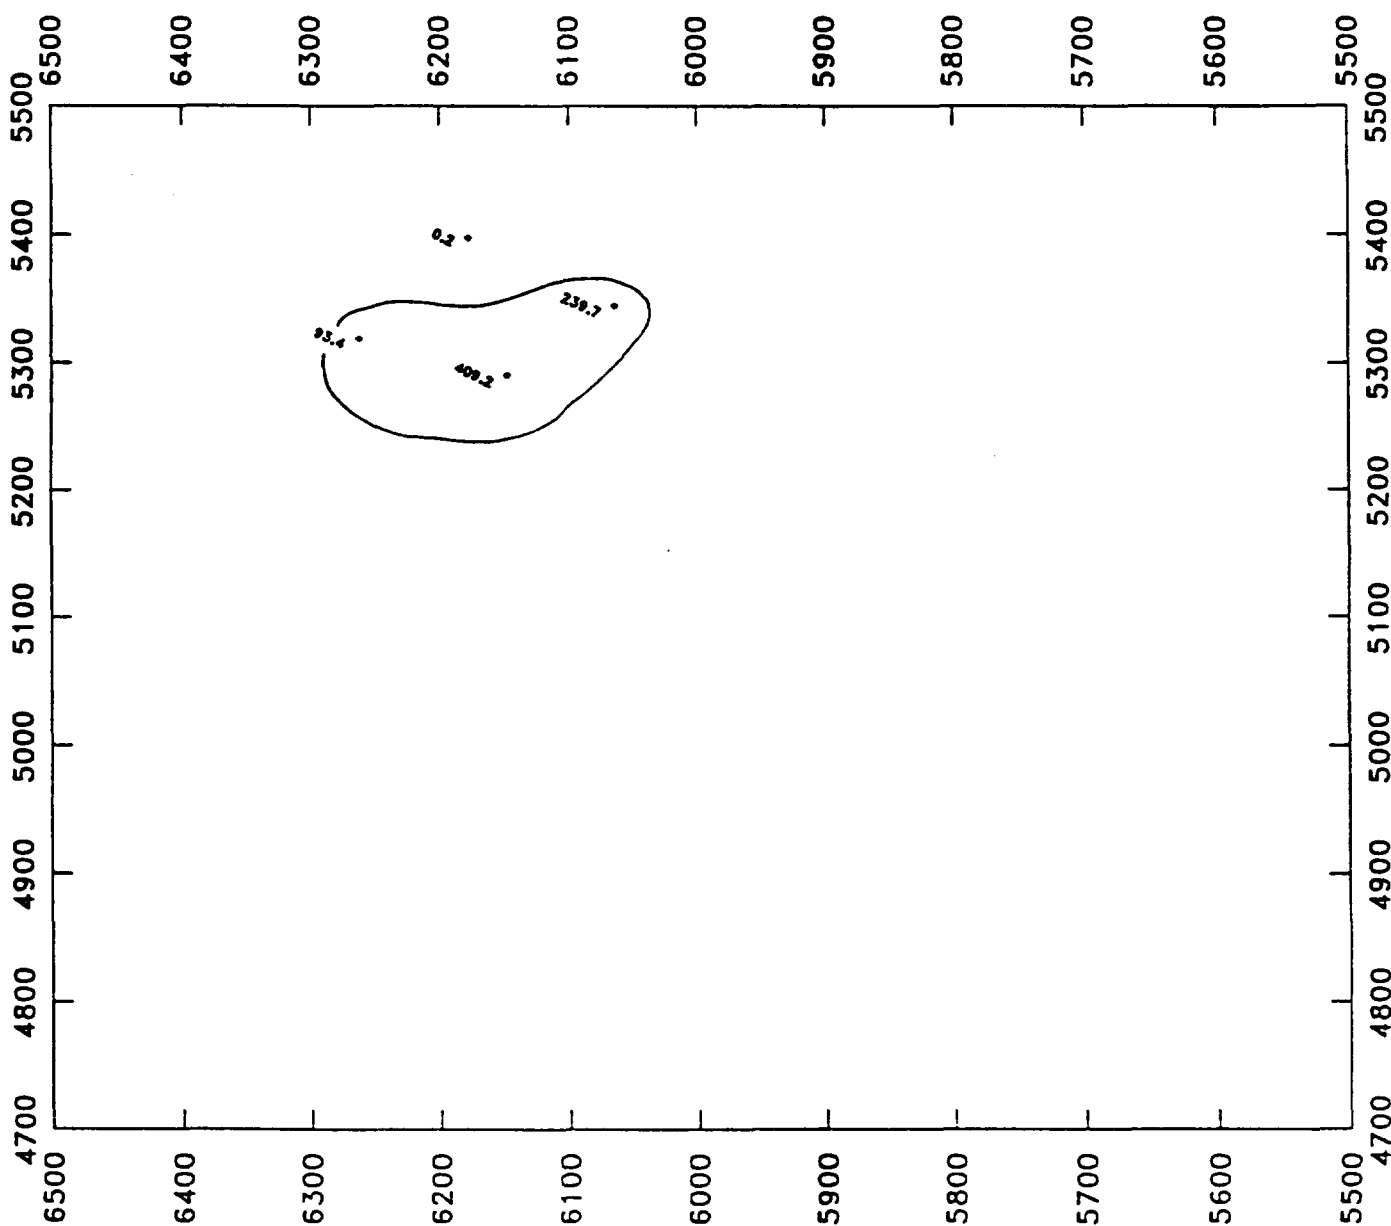
Figure 5-9g Approximate Extent of Total Volatile Wastes (> 1 ppm), Off-Site Areas (24-26 feet below surface). Posted Values are in ppm (mg/kg).

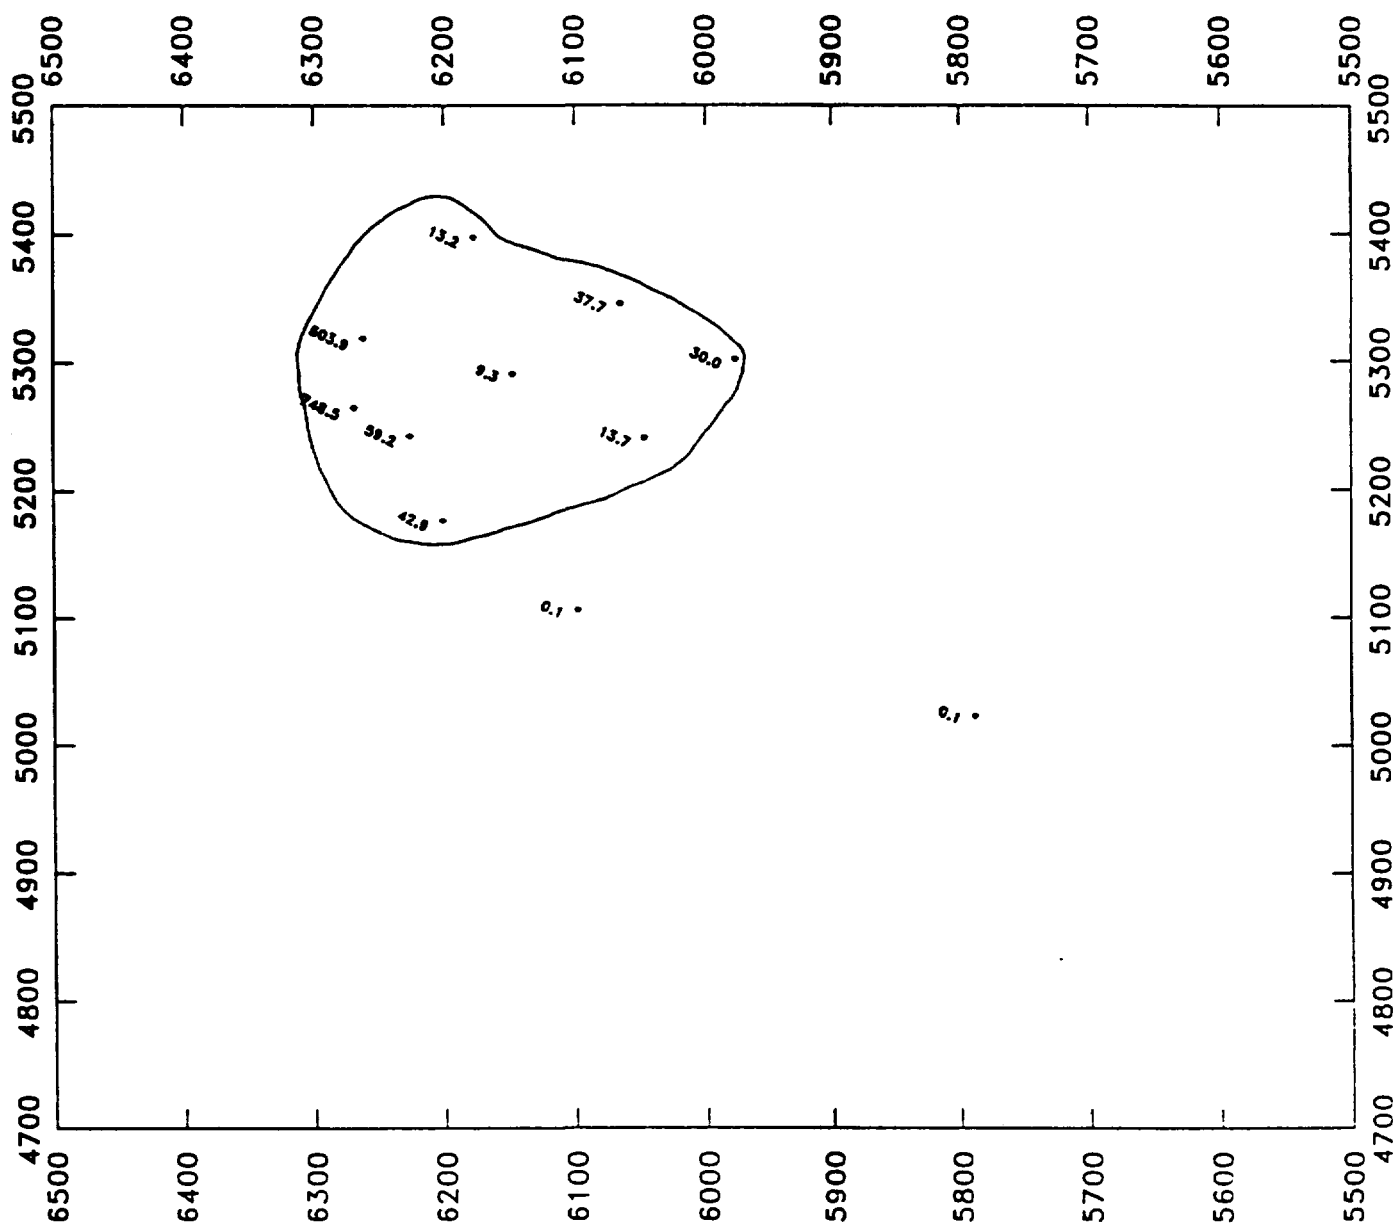
Figure 5-9f Approximate Extent of Total Volatile Wastes (> 1 ppm), Off-Site Areas (19-24 feet below surface). Posted Values are in ppm (mg/kg).
